AN ASSESSMENT OF THE EFFECTS OF HYDROFLUORIC ACID BASED  
CLEANER ON UNGLAZED ARCHITECTURAL TERRACOTTA

A THESIS

Historic Preservation

1999

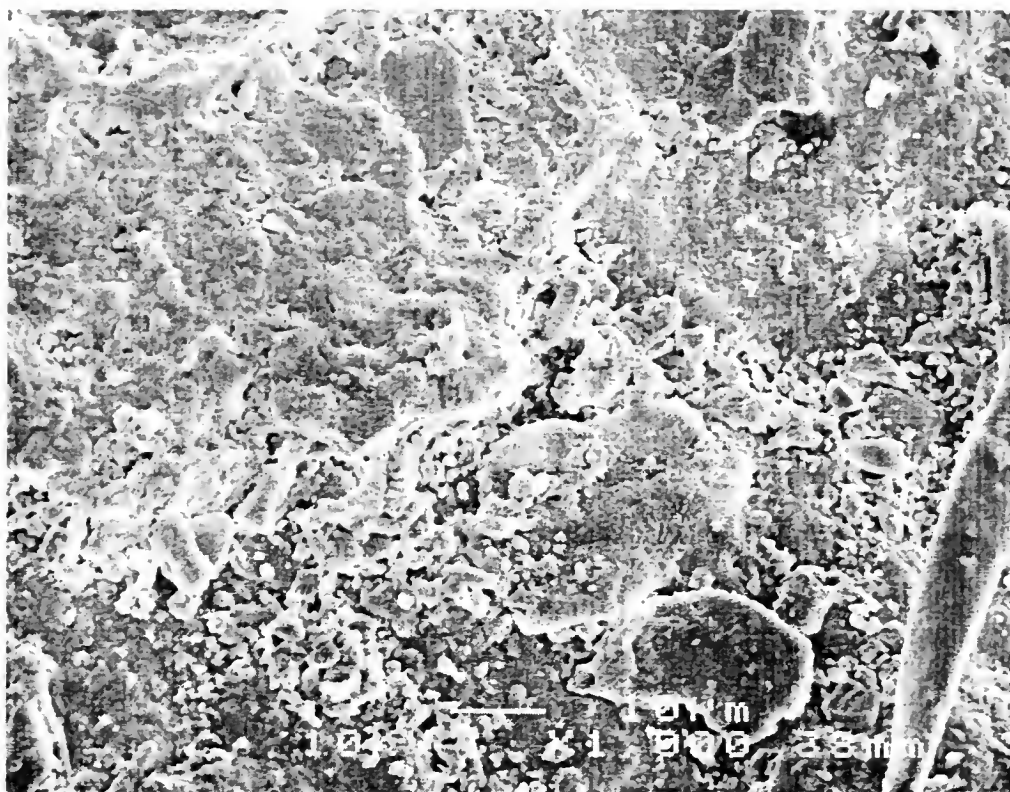
APPENDIX B  
BV-01-0A

BV-01-0A		
AREA	RADIUS	VOLUME
0.223	0.267	0.079
0.531	0.411	0.291
0.708	0.475	0.448
0.770	0.495	0.508
0.816	0.510	0.554
0.839	0.517	0.578
0.862	0.524	0.602
0.877	0.529	0.618
1.216	0.622	1.009
1.608	0.716	1.534
1.742	0.745	1.730
2.778	0.941	3.484
3.840	1.106	5.662

BV-01-0A	BV-01-0
PERCENTAGE OF SURFACE AREA COMPOSED OF PORES	0.22%	0.76%
PERCENTAGE OF TOTAL VOLUME COMPOSED OF PORES	0.04%	0.91%

The following is the pore size distribution as calculated from the measurements taken on the Zidas machine. For each pore measured, the area, radius, and volume are given in chart form. As explained in Chapter Four, the area of each pore was measured and calculated by the Zidas machine. From this area, the radius and volume of each pore were calculated, assuming that the pores were spherical. While it is apparent from the photographs that the pores are in fact not spherical, it is necessary to make this assumption to determine the pore size distribution. The smaller chart gives a summary of the total surface area and volume occupied by pores in the micrograph examined. The average values for the entire sample (as calculated from the sets of micrographs) are included for the purpose of comparison.

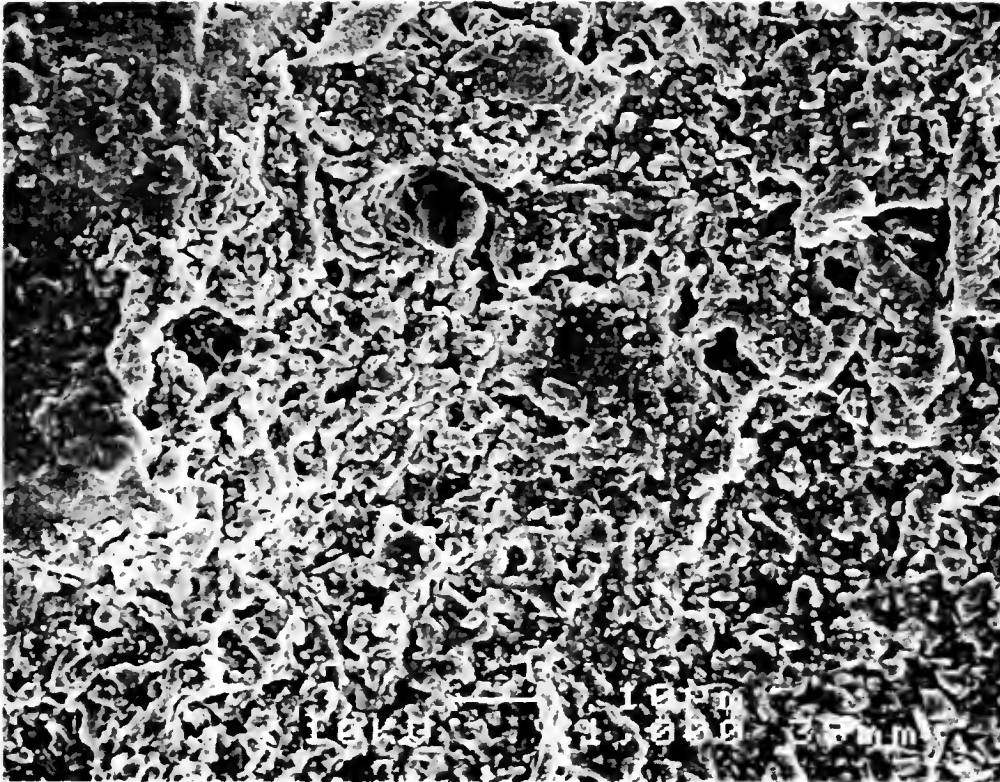
APPENDIX B  
BV-01-0B

BV-01-0B		
AREA	RADIUS	VOLUME
0.377	0.347	0.174
0.408	0.360	0.196
0.485	0.393	0.254
0.493	0.396	0.260
0.569	0.426	0.323
0.616	0.443	0.363
0.754	0.490	0.493
0.785	0.500	0.523
0.785	0.500	0.523
0.831	0.514	0.570
1.016	0.569	0.771
1.039	0.575	0.797
1.062	0.582	0.823
1.331	0.651	1.155
1.600	0.714	1.523

BV-01-0B	BV-01-0
PERCENTAGE OF SURFACE AREA OCCUPIED BY PORES	0.74%	0.76%
PERCENTAGE OF TOTAL VOLUME OCCUPIED BY PORES	0.25%	0.91%

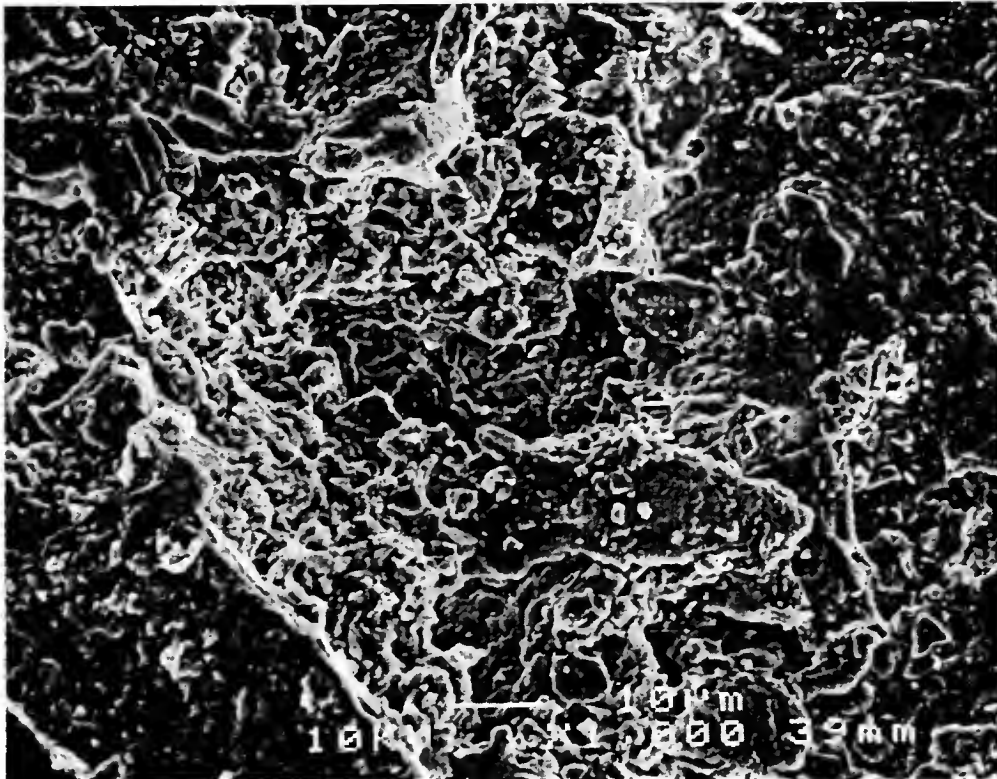
APPENDIX B  
BV-01-0c

BV-01-0c		
AREA	RADIUS	VOLUME
0.600	0.437	0.350
0.639	0.451	0.384
0.677	0.464	0.419
0.939	0.547	0.684
2.155	0.828	2.380
2.939	0.967	3.791
3.170	1.005	4.247
3.409	1.042	4.736
3.740	1.091	5.442
3.793	1.099	5.558
4.386	1.182	6.912
5.140	1.279	8.768
10.130	1.796	24.260
10.610	1.838	26.004
13.830	2.099	38.700

BV-01-0c	BV-01-0
PERCENTAGE OF SURFACE AREA COMPOSED OF PORES	1.32%	0.76%
PERCENTAGE OF TOTAL VOLUME COMPOSED OF PORES	0.61%	0.91%

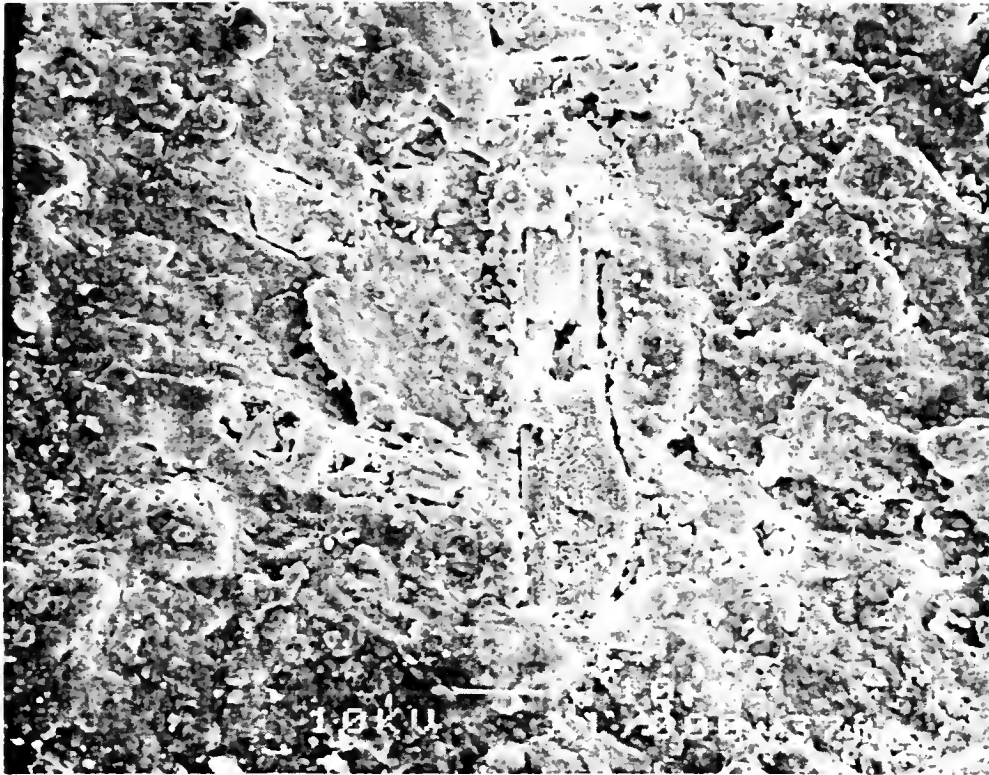
APPENDIX B  
BV-01-3A

BV-01-3A		
AREA	RADIUS	VOLUME
0.239	0.276	0.088
0.308	0.313	0.128
0.346	0.332	0.153
0.362	0.339	0.164
0.500	0.399	0.266
0.500	0.399	0.266
0.531	0.411	0.291
0.554	0.420	0.310
0.600	0.437	0.350
0.600	0.437	0.350
0.754	0.490	0.493
0.770	0.495	0.508
0.785	0.500	0.523
1.139	0.602	0.915
1.477	0.686	1.351
2.262	0.849	2.560

BV-01-3A	BV-01-3
PERCENTAGE OF SURFACE AREA OCCUPIED BY PORES	0.43%	0.29%
PERCENTAGE OF TOTAL VOLUME OCCUPIED BY PORES	0.17%	0.49%

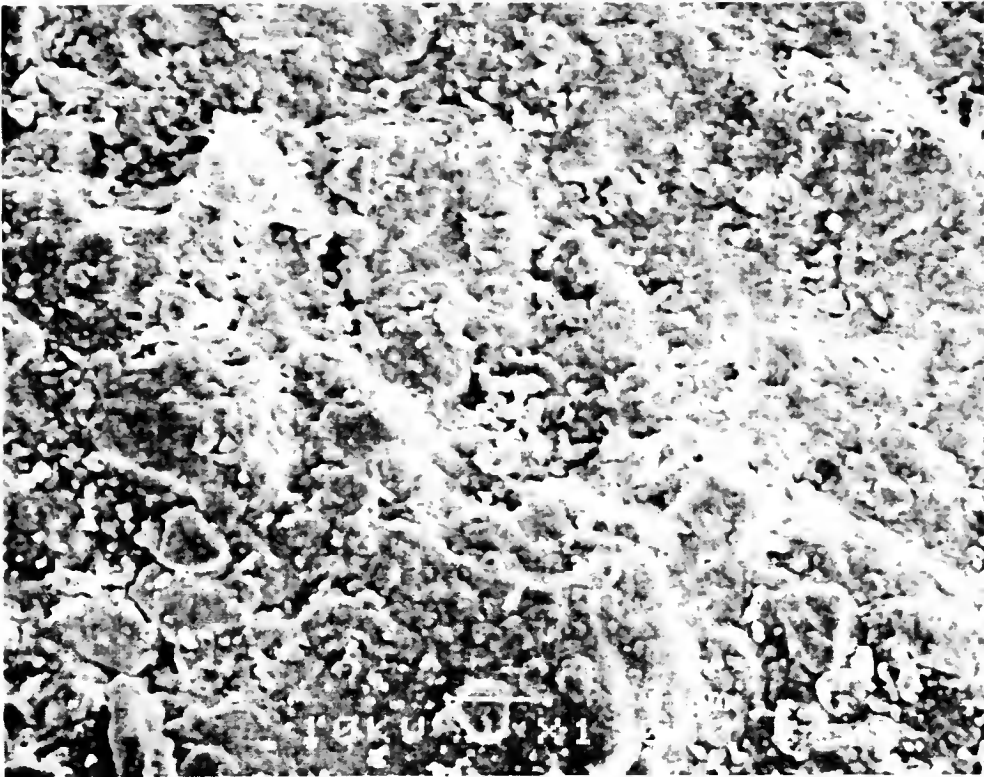
APPENDIX B  
BV-01-3B

BV-01-3B		
AREA	RADIUS	VOLUME
0.246	0.280	0.092
0.285	0.301	0.114
0.339	0.328	0.148
0.354	0.336	0.158
0.400	0.357	0.190
0.446	0.377	0.224
0.562	0.423	0.317
0.577	0.429	0.330
0.631	0.448	0.377
0.677	0.464	0.419
0.993	0.562	0.744
0.993	0.562	0.744
1.108	0.594	0.878
1.193	0.616	0.980
1.400	0.668	1.246

BV-01-3B	BV-01-3
PERCENTAGE OF SURFACE AREA OCCUPIED BY PORES	0.41%	0.29%
PERCENTAGE OF TOTAL VOLUME OCCUPIED BY PORES	0.17%	0.49%

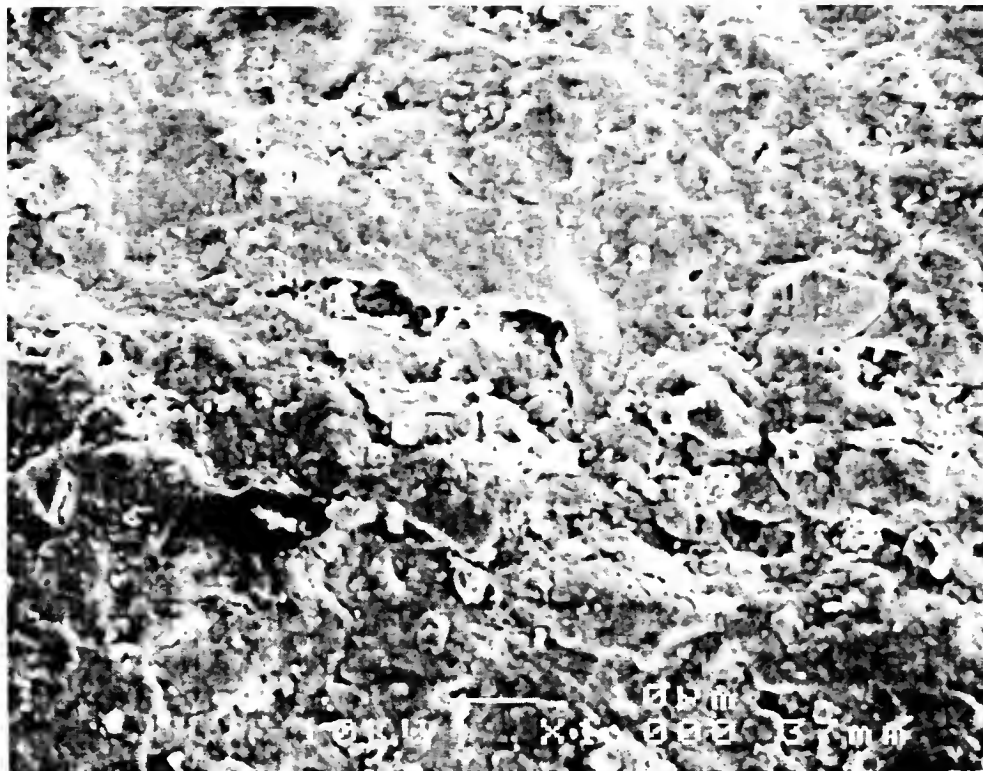
APPENDIX B  
BV-01-3c

BV-01-3c		
AREA	RADIUS	VOLUME
0.292	0.305	0.119
0.362	0.339	0.164
0.385	0.350	0.180
0.469	0.387	0.242
0.531	0.411	0.291
0.569	0.426	0.323
0.708	0.475	0.448
0.752	0.489	0.490
0.916	0.540	0.659
0.993	0.562	0.744
1.000	0.564	0.752
1.131	0.600	0.905
1.277	0.638	1.086
1.839	0.765	1.876
2.078	0.814	2.254

BV-01-3c	BV-01-3
PERCENTAGE OF SURFACE AREA OCCUPIED BY PORES	0.45%	0.29%
PERCENTAGE OF TOTAL VOLUME OCCUPIED BY PORES	0.15%	0.49%

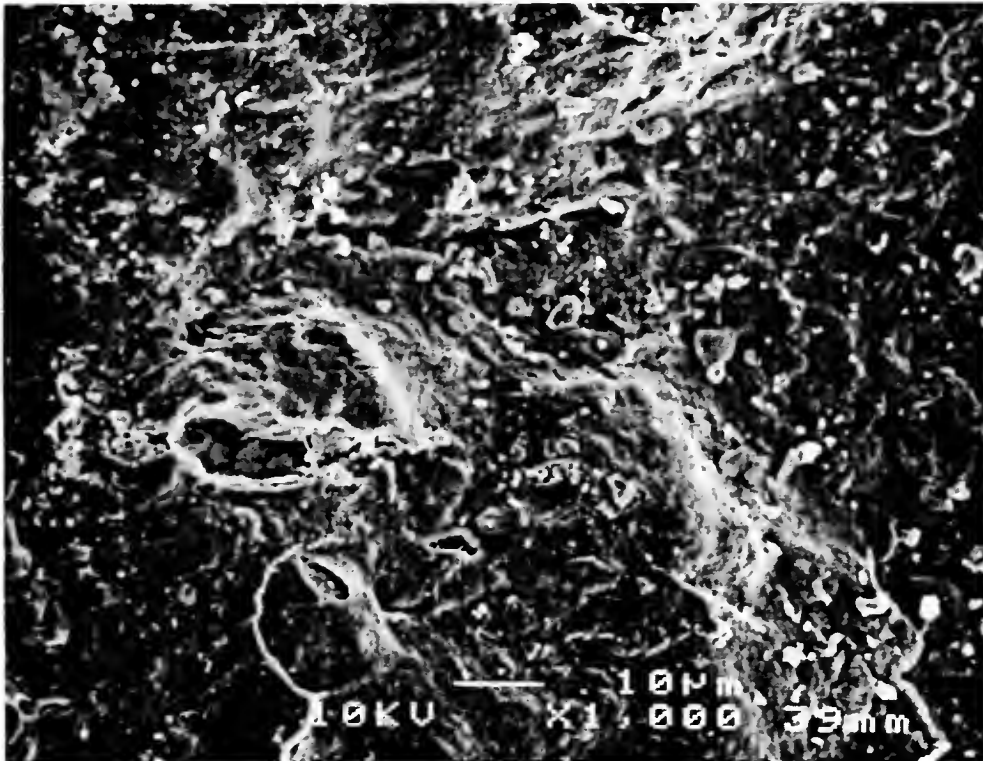
APPENDIX B  
GMB-01-0A

GMB-01-0A		
AREA	RADIUS	VOLUME
0.577	0.429	0.330
1.254	0.632	1.057
2.331	0.862	2.678
2.832	0.950	3.586
3.486	1.054	4.897
4.532	1.201	7.260
5.117	1.277	8.710
5.894	1.370	10.767
7.318	1.527	14.896
10.330	1.814	24.982
10.680	1.844	26.262

GMB-01-0A	GMB-01-0
PERCENTAGE OF SURFACE AREA OCCUPIED BY PORES	0.70%	1.27%
PERCENTAGE OF TOTAL VOLUME OCCUPIED BY PORES	0.15%	0.52%

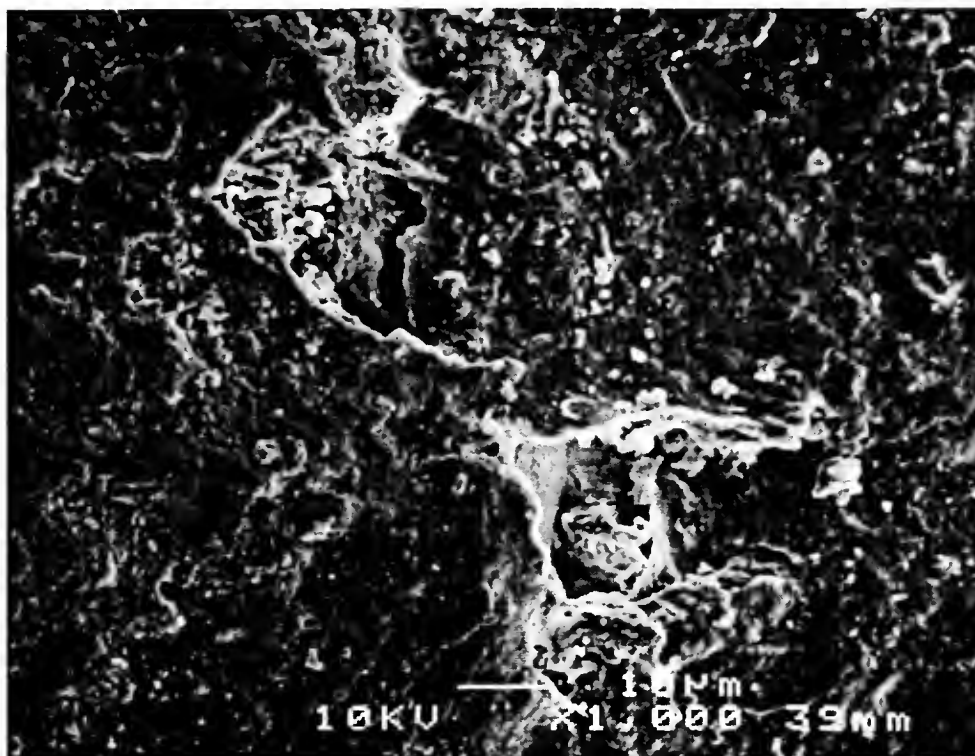
APPENDIX B  
GMB-01-0B

GMB-01-0B		
AREA	RADIUS	VOLUME
0.508	0.402	0.272
0.593	0.434	0.343
0.646	0.454	0.391
0.723	0.480	0.463
0.839	0.517	0.578
0.993	0.562	0.744
1.170	0.610	0.952
1.500	0.691	1.382
1.685	0.733	1.646
2.124	0.822	2.329
2.239	0.844	2.521
2.924	0.965	3.762
3.086	0.991	4.079
3.701	1.086	5.357
7.402	1.535	15.153

GMB-01-0B	GMB-01-0
PERCENTAGE OF SURFACE AREA OCCUPIED BY PORES	1.15%	1.27%
PERCENTAGE OF TOTAL VOLUME OCCUPIED BY PORES	0.40%	0.52%

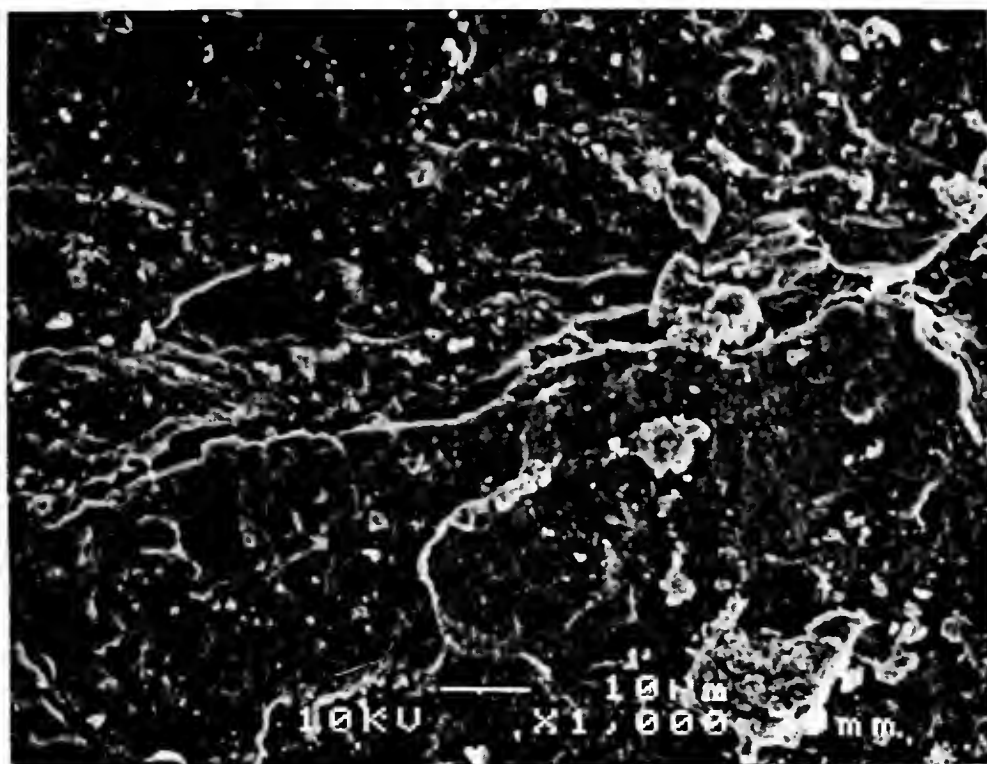
APPENDIX B  
GMB-01-0c

GMB-01-0c		
AREA	RADIUS	VOLUME
0.308	0.313	0.128
0.331	0.325	0.143
0.754	0.490	0.493
1.239	0.628	1.038
2.401	0.874	2.799
5.355	1.306	9.324
19.110	2.467	62.859
21.660	2.626	75.851
38.550	3.504	180.099
61.200	4.415	360.248

GMB-01-0c	GMB-01-0
PERCENTAGE OF SURFACE AREA OCCUPIED BY PORES	1.94%	1.27%
PERCENTAGE OF TOTAL VOLUME OCCUPIED BY PORES	1.01%	0.52%

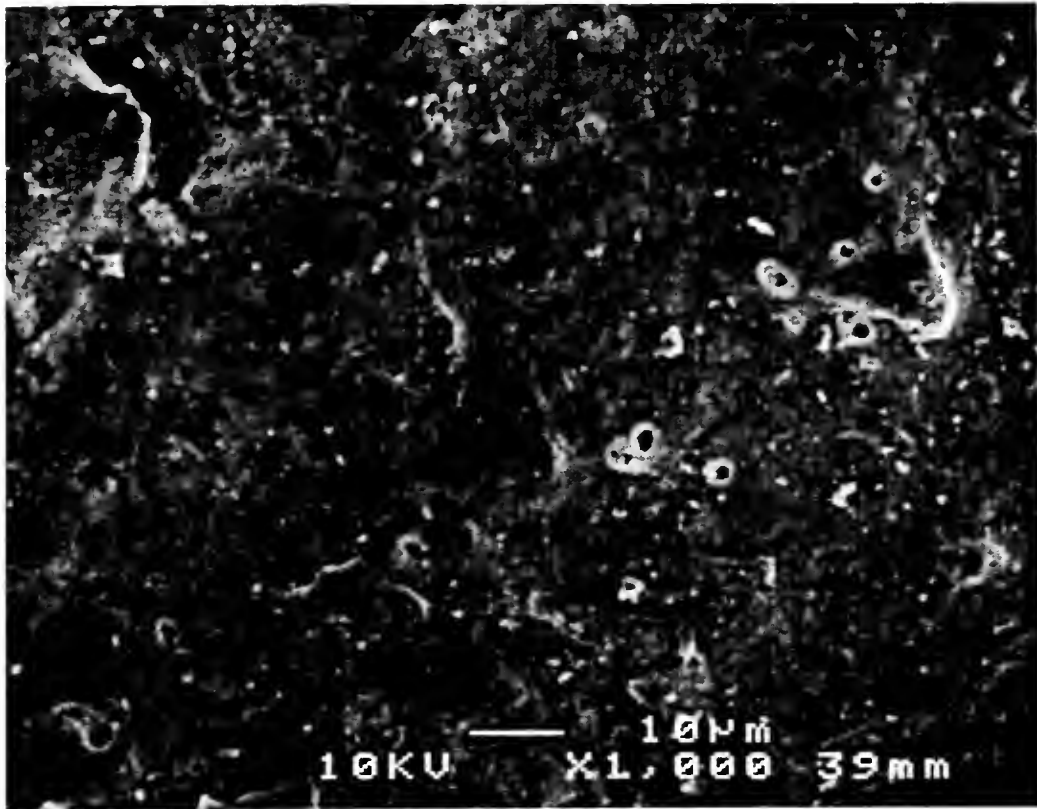
APPENDIX B  
GMB-01-3A

GMB-01-3A		
AREA	RADIUS	VOLUME
0.185	0.243	0.060
0.223	0.267	0.079
0.477	0.390	0.248
0.546	0.417	0.304
0.685	0.467	0.426
0.823	0.512	0.562
0.916	0.540	0.659
1.093	0.590	0.860
1.162	0.608	0.943
1.185	0.614	0.971
1.893	0.776	1.960
1.916	0.781	1.996
2.131	0.824	2.341
2.370	0.869	2.745

GMB-01-3A	GMB-01-3
PERCENTAGE OF SURFACE AREA OCCUPIED BY PORES	2.54%	2.46%
PERCENTAGE OF TOTAL VOLUME OCCUPIED BY PORES	1.24%	0.73%

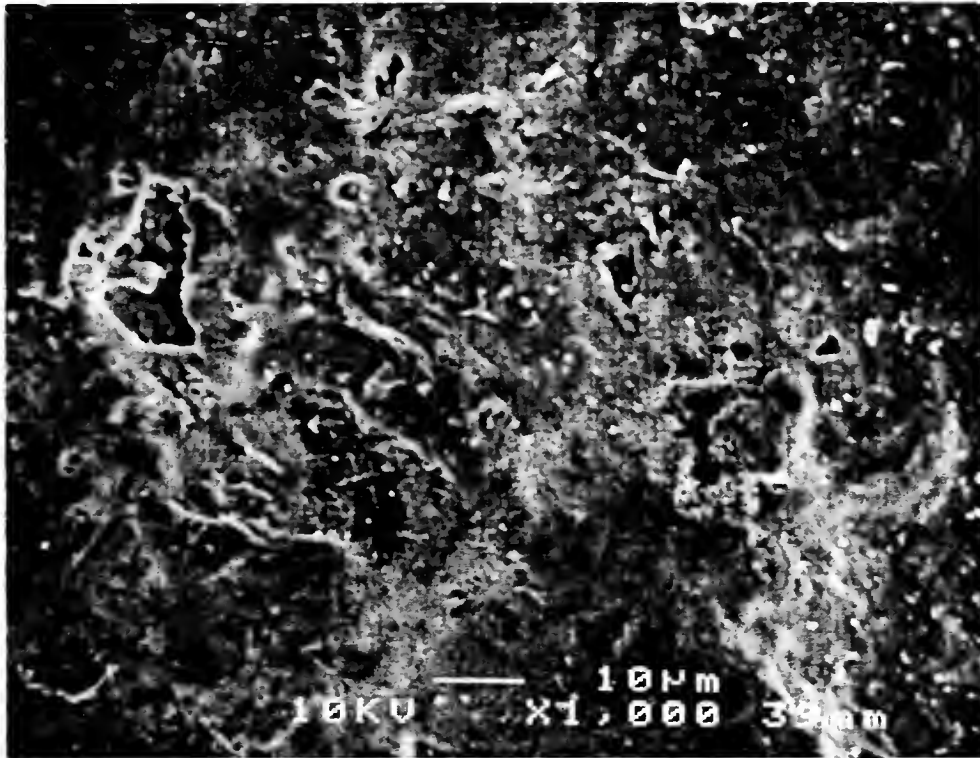
APPENDIX B  
GMB-01-3B

GMB-01-3B		
AREA	RADIUS	VOLUME
0.523	0.408	0.285
1.139	0.602	0.915
1.154	0.606	0.933
1.308	0.645	1.126
1.916	0.781	1.996
2.139	0.825	2.354
2.278	0.852	2.587
2.393	0.873	2.785
3.055	0.986	4.018
3.409	1.042	4.736
3.994	1.128	6.006
4.070	1.138	6.178
4.871	1.246	8.089
5.155	1.281	8.807
11.270	1.895	28.468

GMB-01-3B	GMB-01-3
PERCENTAGE OF SURFACE AREA OCCUPIED BY PORES	2.17%	2.46%
PERCENTAGE OF TOTAL VOLUME OCCUPIED BY PORES	1.02%	0.73%

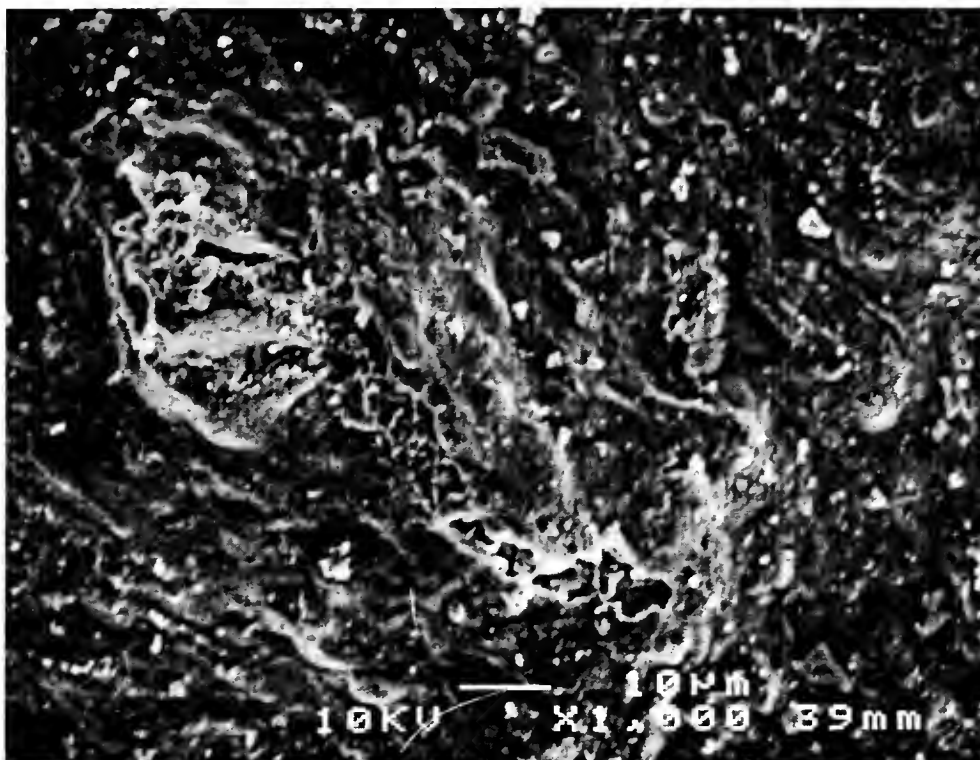
APPENDIX B  
GMB-01-3c

GMB-01-3c		
AREA	RADIUS	VOLUME
0.762	0.493	0.500
0.931	0.545	0.676
0.985	0.560	0.735
1.139	0.602	0.915
1.208	0.620	0.999
1.316	0.647	1.136
1.685	0.733	1.646
3.016	0.980	3.941
4.501	1.197	7.185
4.594	1.210	7.409
5.463	1.319	9.608
5.694	1.347	10.224
7.679	1.564	16.011
8.441	1.640	18.453
28.490	3.012	114.423

GMB-01-3c	GMB-01-3
PERCENTAGE OF SURFACE AREA OCCUPIED BY PORES	1.92%	2.46%
PERCENTAGE OF TOTAL VOLUME OCCUPIED BY PORES	0.66%	0.73%

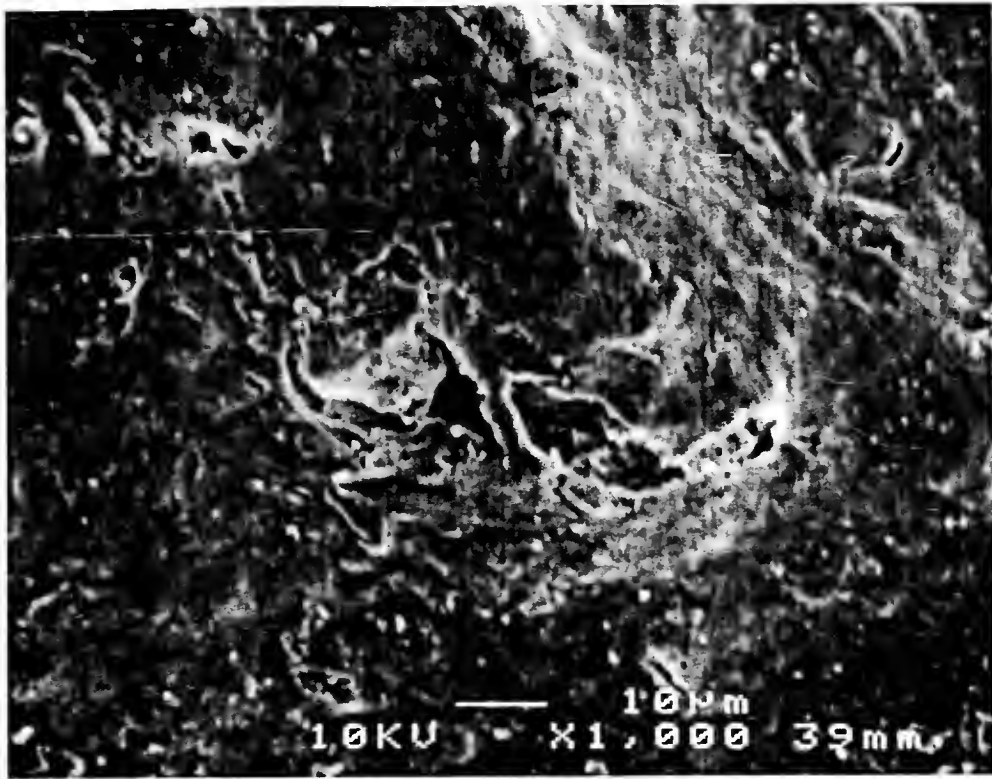
APPENDIX B  
GMB-01-3D

GMB-01-3D		
AREA	RADIUS	VOLUME
0.469	0.387	0.242
0.954	0.551	0.701
1.370	0.661	1.207
1.600	0.714	1.523
1.639	0.722	1.579
2.362	0.867	2.731
3.001	0.978	3.912
3.270	1.020	4.449
3.455	1.049	4.832
3.670	1.081	5.290
6.240	1.410	11.729
11.730	1.933	30.229
12.010	1.956	31.318
12.800	2.019	34.458
13.480	2.072	37.240

GMB-01-3D	GMB-01-3
PERCENTAGE OF SURFACE AREA OCCUPIED BY PORES	3.23%	2.46%
PERCENTAGE OF TOTAL VOLUME OCCUPIED BY PORES	0.66%	0.73%

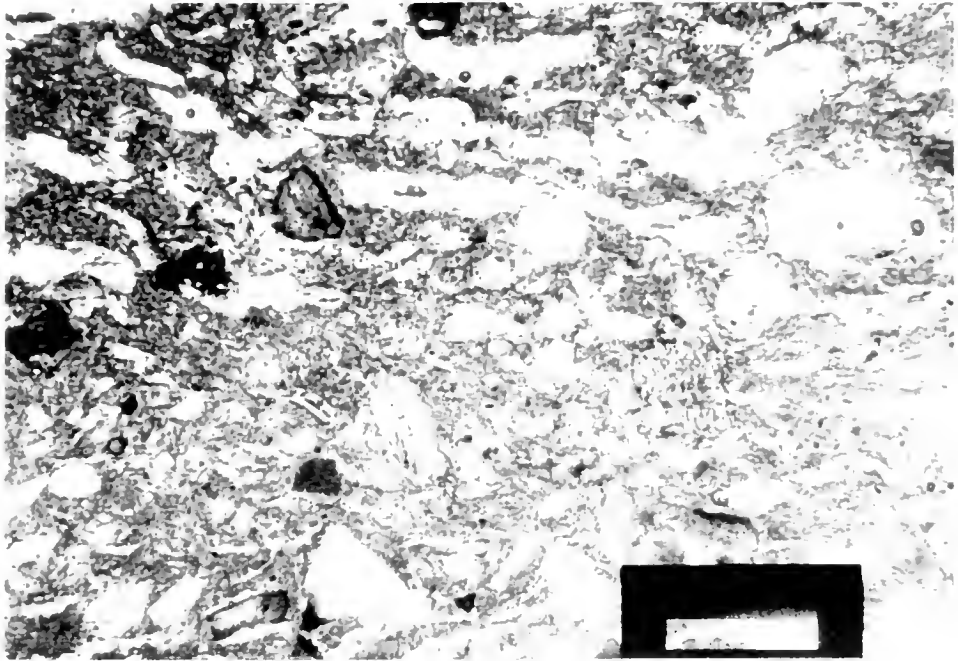
Treated Boston Valley sample at 25X, transmitted light

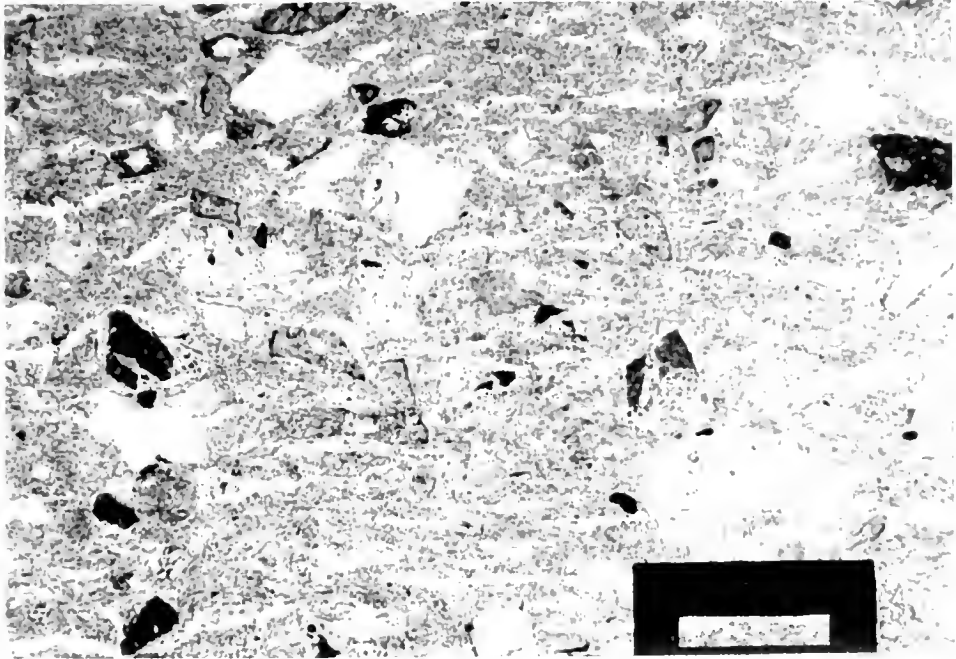
Untreated Boston Valley sample at 25X, transmitted light

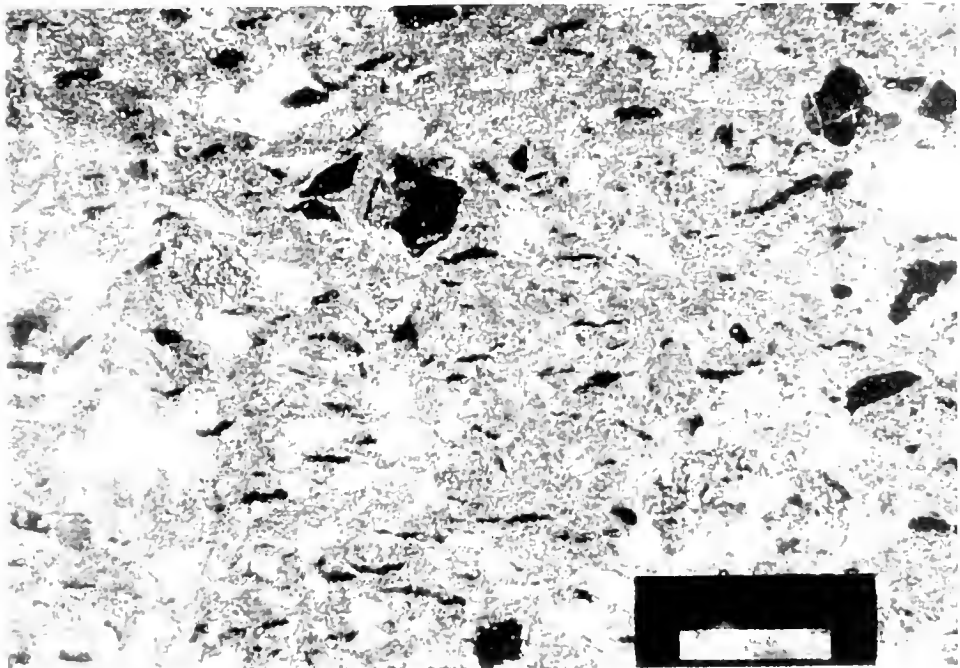
Untreated Boston Valley sample at 25X, transmitted polarized light

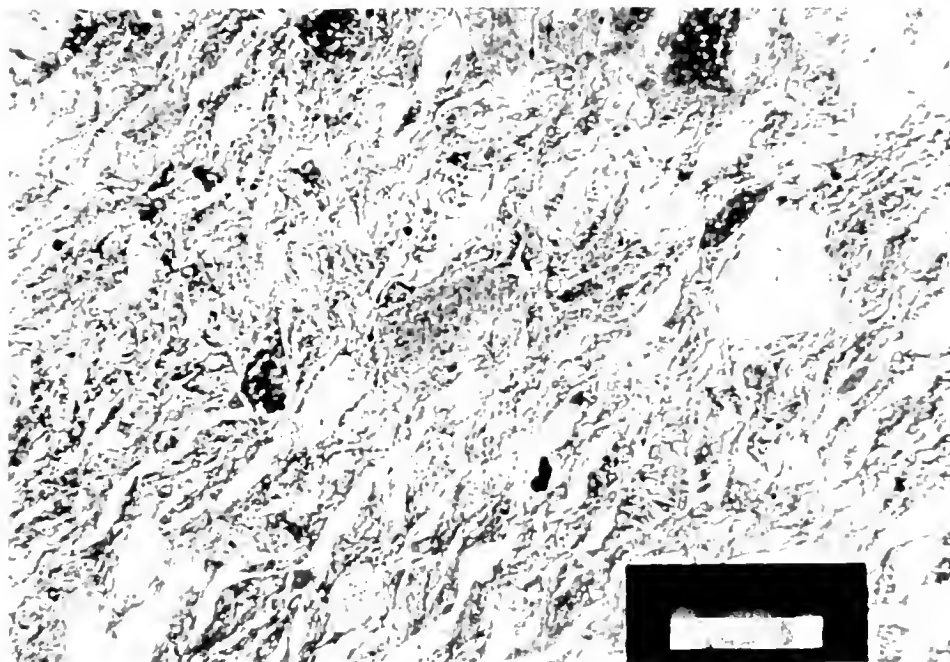
Untreated Gladding, McBean sample at 25X, transmitted light

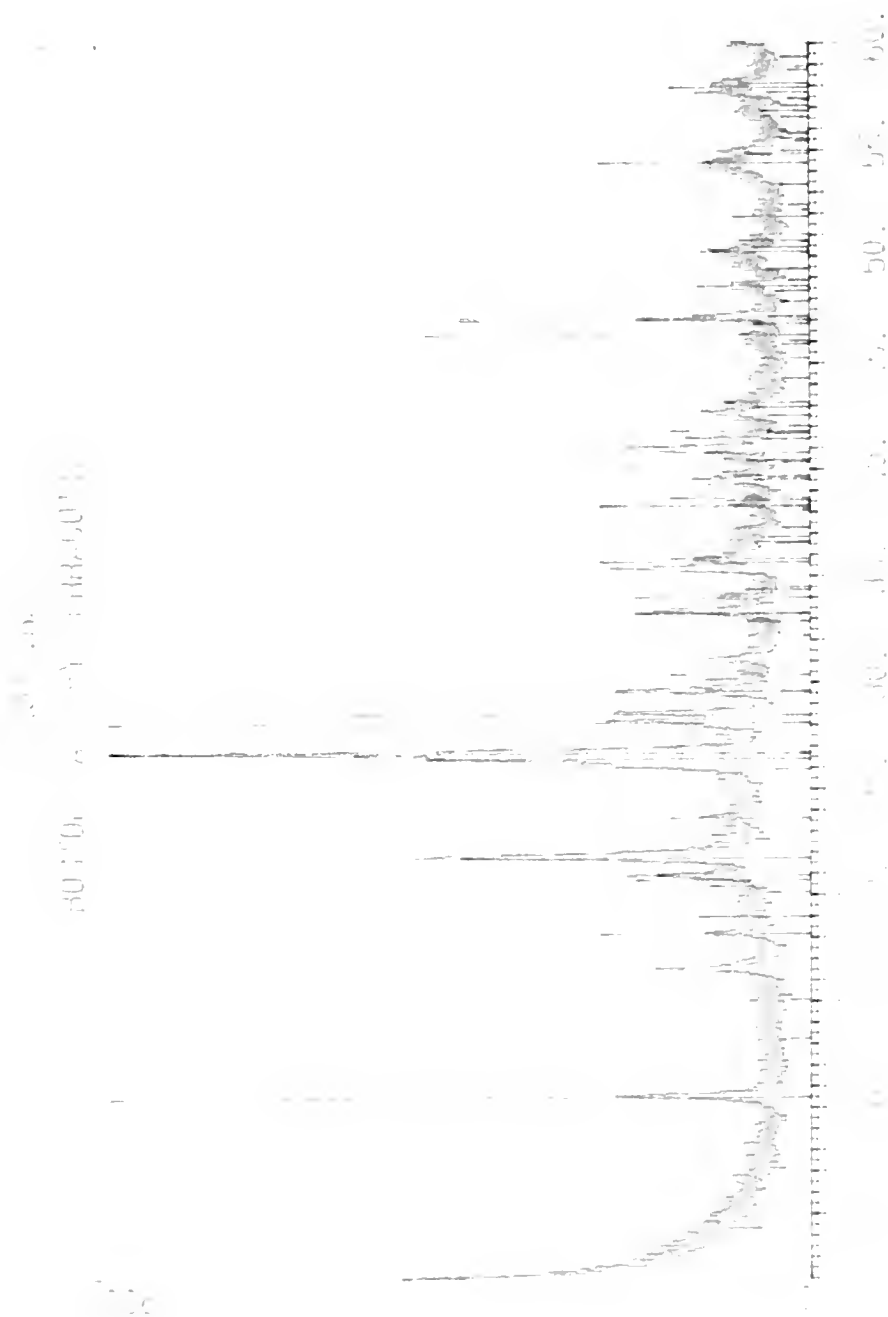
MINERAL NAME	PEAK COLOR
Indialite	violet
Mullite	yellow
Quartz	green
Kyanite	black

The two prevalent crystalline structures common to the two terracottas were mullite ( $\text{Al}_6\text{Si}_2\text{O}_{13}$ ), and quartz ( $\text{SiO}_2$ ). Kyanite and aluminum phosphate were also found in both types of terracotta, although each was prominent in one type and trace in another. As would be expected, with the exception of aluminum phosphate, all of these components are various types of silicates. Silicates compose the majority of the earth's crust, and are frequently the basis of building materials.<sup>82</sup> The unit cell of all silicates is the tetrahedron; silicates are classified according to the preferred bonding structure of these tetrahedra to each other.

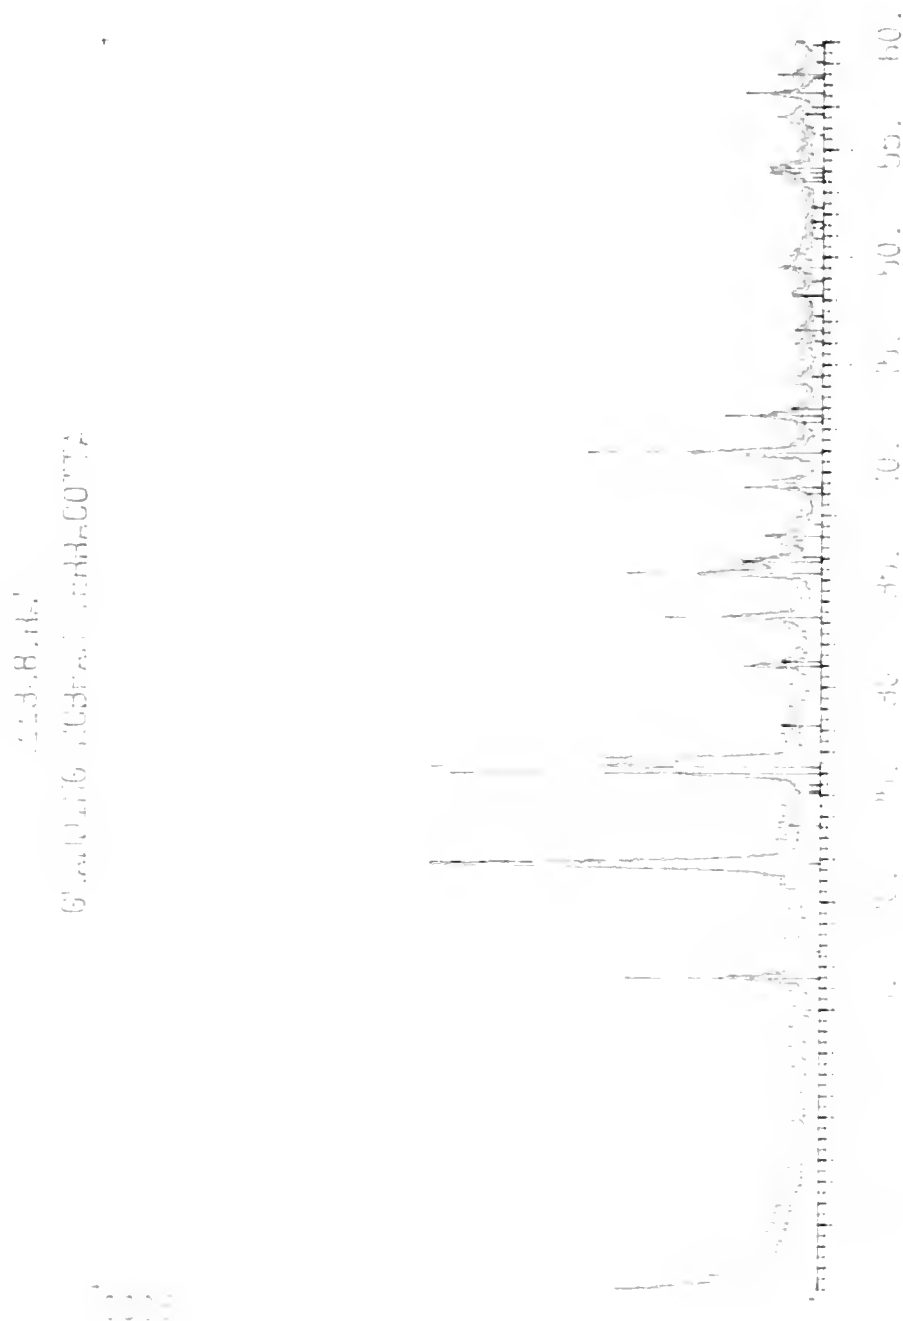
MINERAL NAME	PEAK COLOR
Mullite	violet
Aluminum Phosphate	green
Quartz	yellow
